# Complete denture fracture – A proposed classification system and its incidence in National Capital Region population: A survey

## Abstract

**Aim:** The complete denture fracture of denture may ruin the routine life of an edentulous patient. The aim of the present study was to propose and evaluate a new classification system for denture fractures.

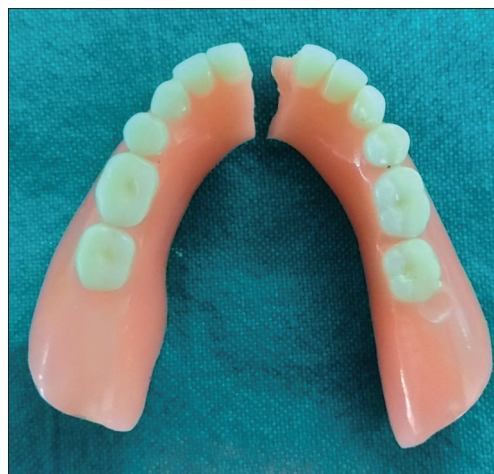
Figure 1: Class I mandibular denture fracture

- Class I: The fracture line passes through the midline between the central incisors extending to the posterior extension. The fractured fragments may or may not be completely separated [Figures 1 and 2]
- Class II: The fracture line passes through other than midline in a diagonal direction extending to the posterior extension. The fractured fragments may or may not be completely separated [Figure 3]
- Class III: The fracture line is moon shape passing through the labial or buccal flange. The fractured fragment may or may not be separated [Figure 4]
- Class IV: The fracture line passes through dentoalveolar structure of the denture, involving two or more teeth. In this denture, base continuity is preserved [Figure 5]
- Class V: The fracture of a part of artificial tooth or separation of a single tooth from denture [Figures 6 and 7].

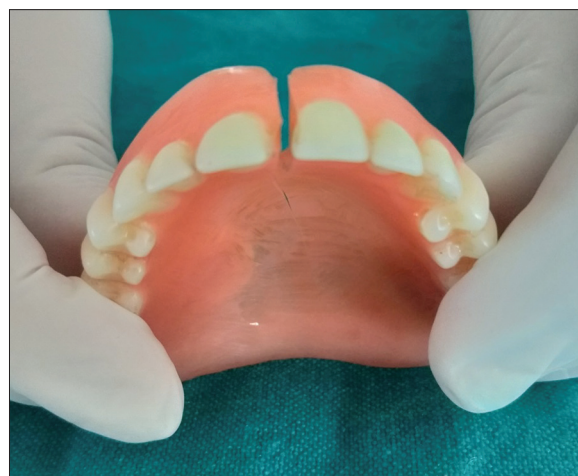
Figure 2: Class I maxillary denture fracture

In this study, Class I was the most common fracture found (46.87% in maxillary and 61% in mandibular dentures) which is in agreement with the previous studies.<sup>[2,9,11]</sup> Midline fracture in the upper denture has been related to the cyclic deformation of the base during function.<sup>[9]</sup> Fracture usually originates from the labial notch area which should be rounded than a sharp one.<sup>[12]</sup> The less surface area and thinness in the middle part of the lower denture are responsible for the fracture. Besides, accidental dropping of denture, patient negligence during insertion, and removal and cleaning of denture are among the major causative factors for lower denture fracture.<sup>[11]</sup> The study revealed near about 24% of Class II fractures of the lower dentures which is comparable to the report by Khalid.<sup>[10]</sup> The use of strengtheners such as metal frame or wire in denture bases has found to reduce denture base fracture, but it increased tooth debonding. These kinds of reinforcements hold the pieces together if fracture occurs but weakens the base creating stress concentration points, especially at tooth bonding surfaces.<sup>[13]</sup> However, the problem of acrylic resin fracture can be reduced by the use of high-impact resins.<sup>[14]</sup> Electrical glass partial fiber reinforcement has significantly proved to enhance the mechanical strength of denture bases.<sup>[15]</sup>

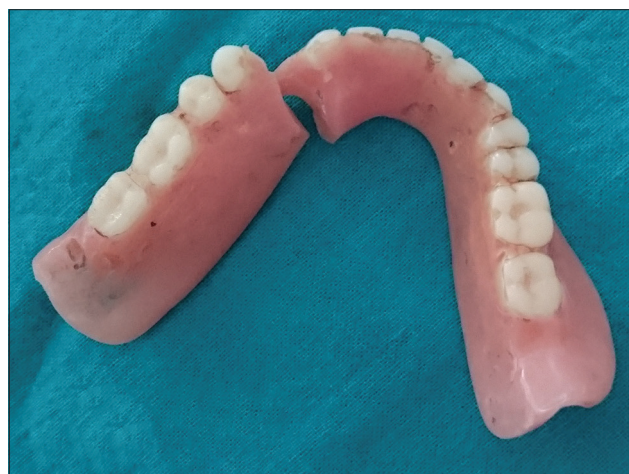
Figure 3: Class II mandibular denture fracture

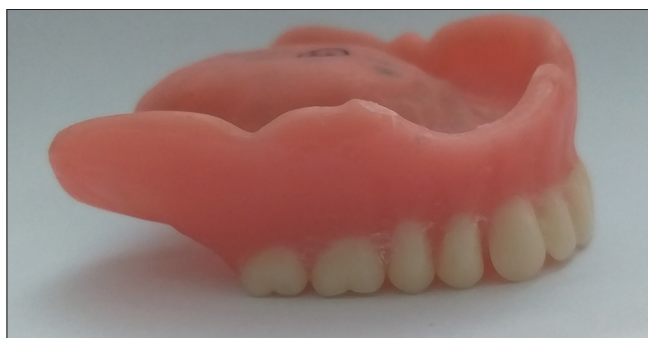
**Figure 4:** Class III maxillary denture fracture

According to the proposed classification system, Class III fracture presents a fracture line in moon shape passing through the labial or buccal flange of complete denture. Our results showed that 16.4% of maxillary dentures presented with this which was in agreement with previous studies. This has been termed as border or flange fractures.<sup>[17]</sup> On the contrary, no single case was found of Class III fracture for mandibular denture that can be due to short flanges and thin mandibular dentures in whole.<sup>[11]</sup>

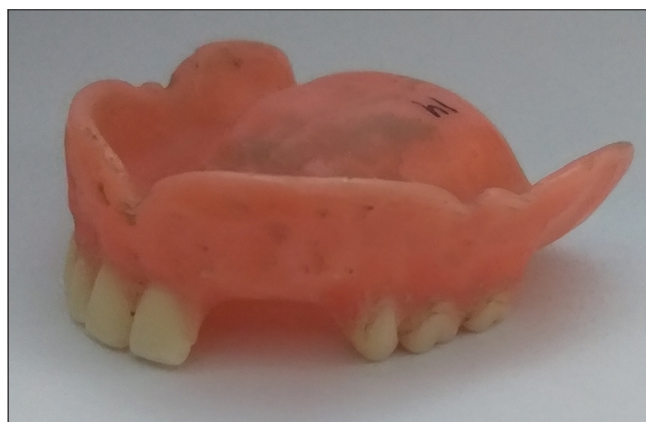
**Figure 5:** Class IV maxillary denture fracture

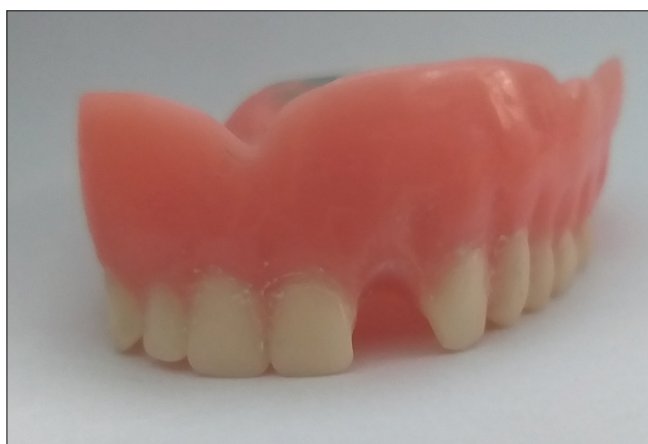
**Figure 6:** Class V maxillary denture fracture

The prevalence of broken and debonded teeth (Class V) was significantly more in the maxilla with 28.12% of total upper dentures. Similar results were found by Zisis *et al.*<sup>[9]</sup> Vallittu *et al.* also found a high prevalence of denture

fracture resulting from teeth debonding (26%).<sup>[3]</sup> This type of failure may be attributed to lesser ridge lap surface areas available for bonding, polymerization of acrylic resin, or wax remaining between the surface of artificial teeth and denture base acrylic resin.<sup>[7,16]</sup>

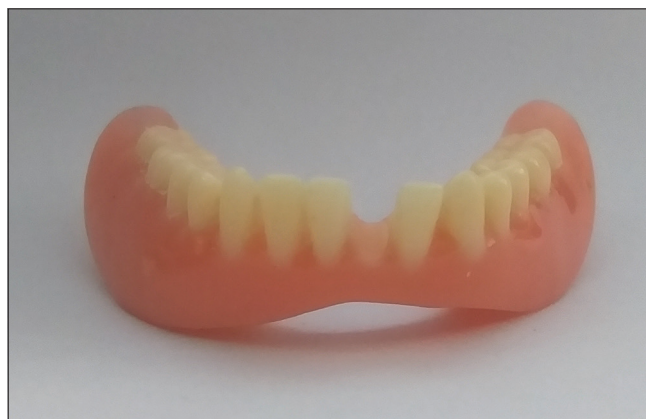
**Figure 7:** Class V mandibular denture fracture

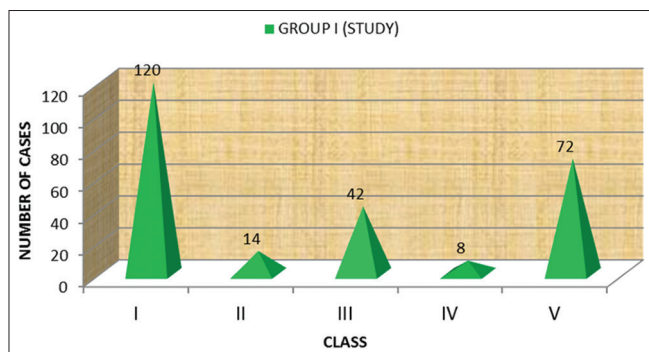
**Graph 1: Distribution of maxillary denture fracture according to class**

Class I fracture (midline) was the most common in both maxillary and mandibular dentures with a percentage of 46.87% in maxillary [Table 2 and Graph 1] and 61% in mandibular fractured dentures ( $P < 0.001$ ) [Table 3 and Graph 2]. It was observed that Class II was the second most common pattern of fracture in mandibular dentures with 24% of total lower dentures ( $P < 0.001$ ) followed by Class V fractures [Table 3 and Graph 2].

For the maxillary dentures, Class V fracture was the second most common fracture found (28.12%) followed by Class III fractures (16.40%) [Table 2 and Graph 1].

was also significantly less for the maxillary dentures reported [Table 2 and Graph 1].

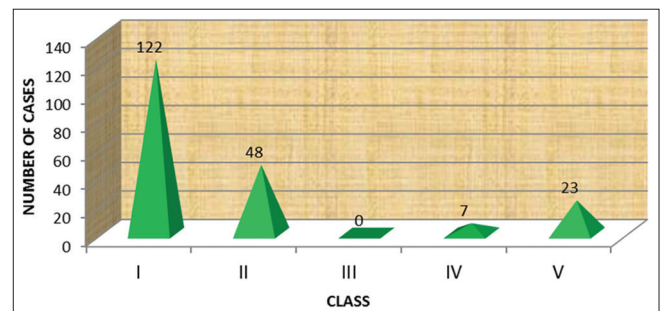
**Graph 2: Distribution of mandibular denture fracture according to class**

There was no single case of Class III fracture for the mandibular dentures, and Class IV fracture also occurred relatively infrequently (only 3.5%) [Table 3 and Graph 2]. The percentage of Class II (5.4%) and IV fractures (3.12%)
